Report on Increased
Surface Water Flood Risk
on
Common Road, Weston Colville,
Cambridgeshire
(Updated)

Author: A Durham
17 April 2022

A Report on the Increased Risk of Surface Water Flooding on Common Road, Weston Colville, Cambridgeshire CB21 5NS

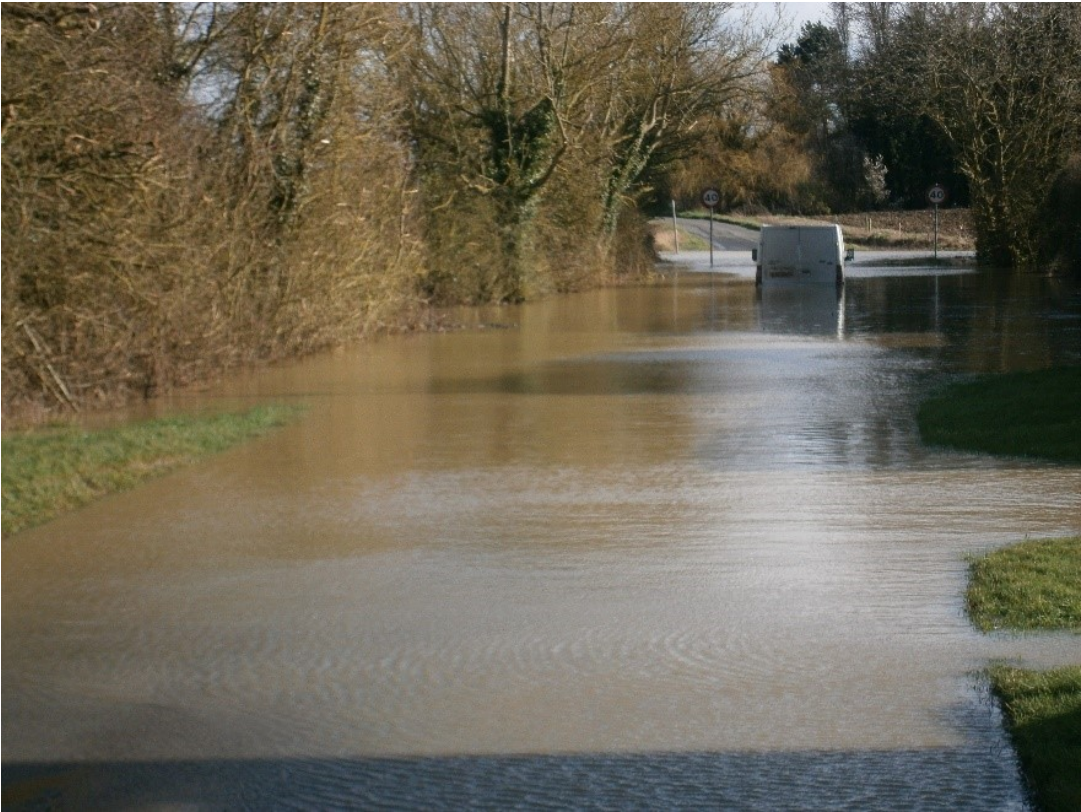
Photograph no.1 taken of Restriction 1 on 29 February 2020 . The flooded van gives an indication of depth.

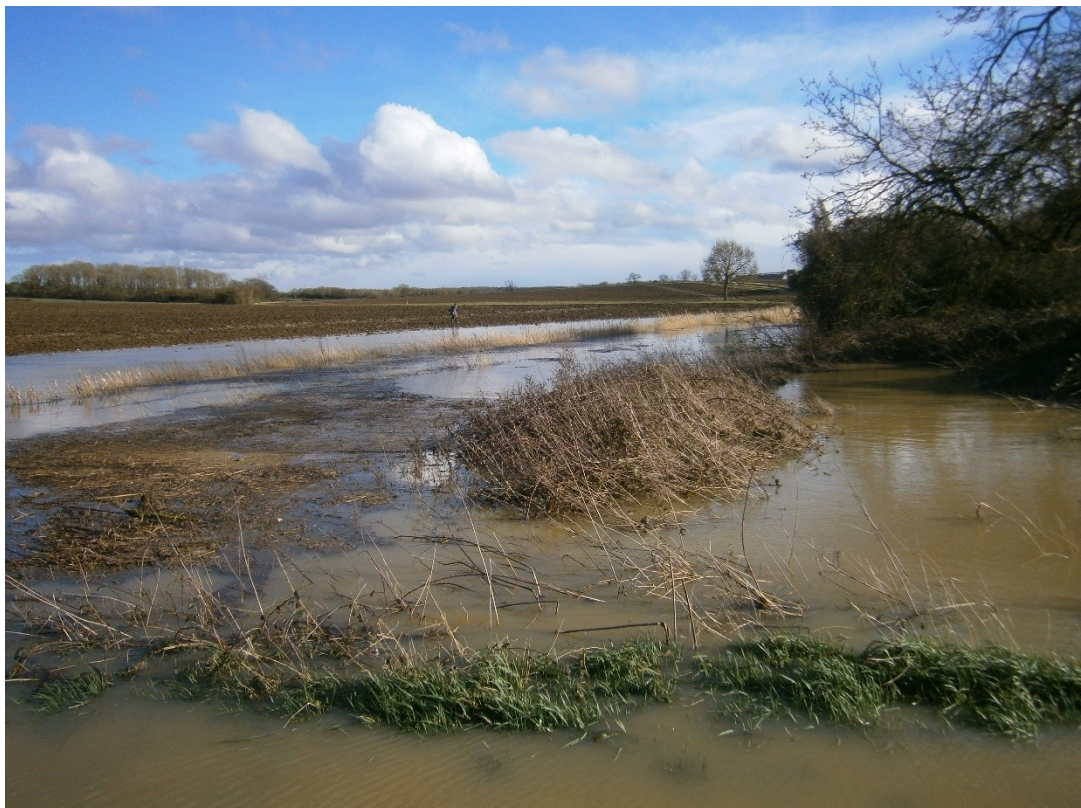
Photograph no.2 taken of land between Restriction 1 and 2 on 29 February 2020 .

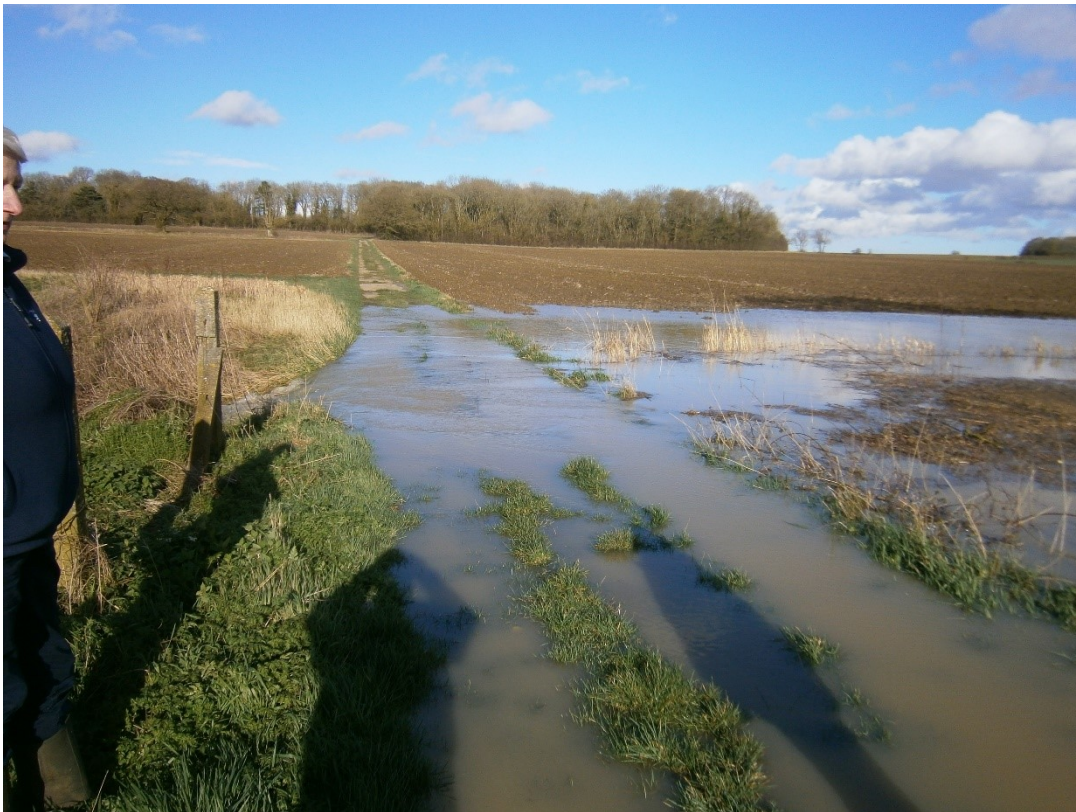
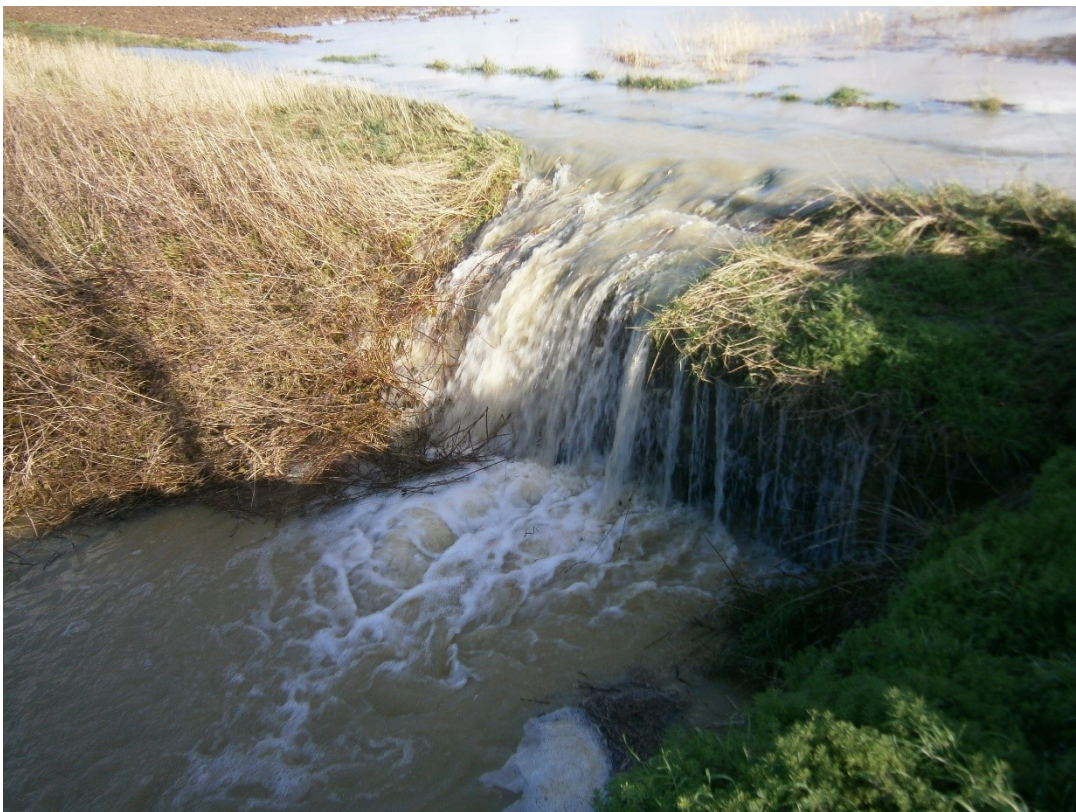
Photographs no.3 a & b taken of Restriction 2 on 29 February 2020 . Note the difference in height of the water level.

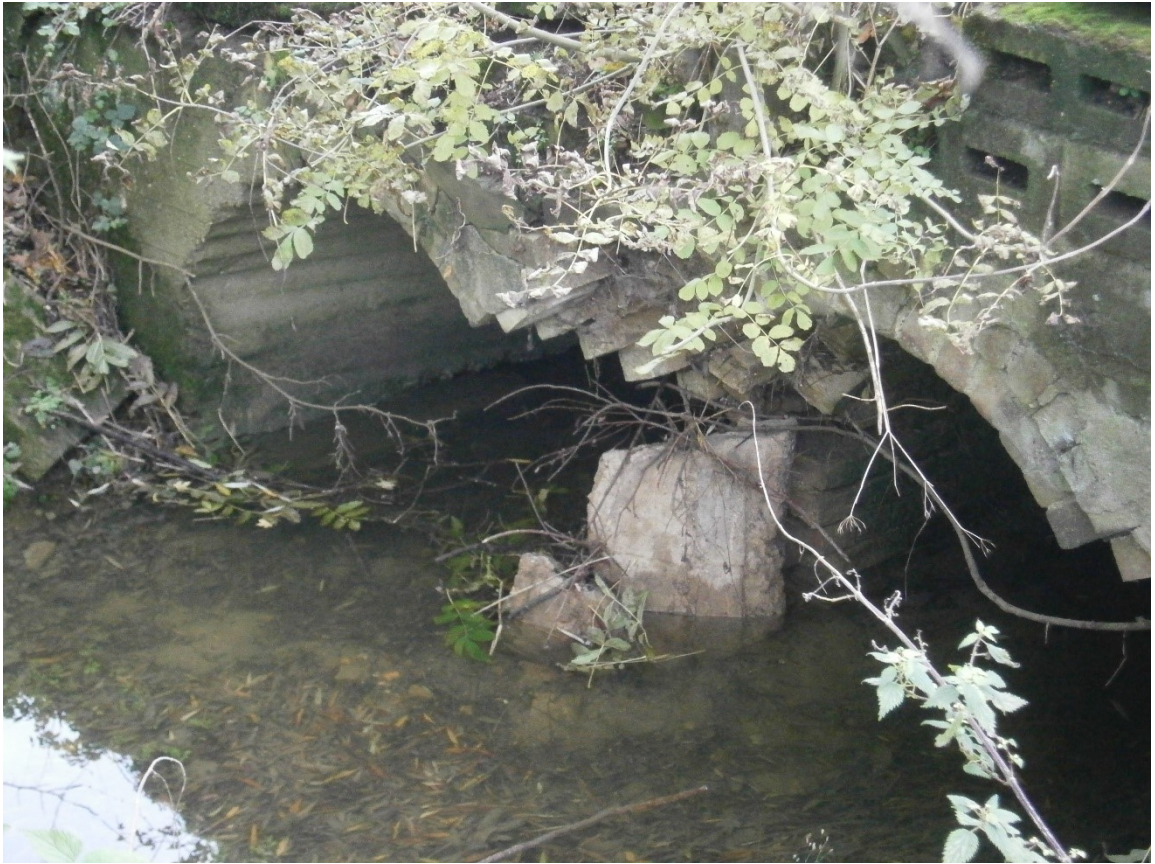
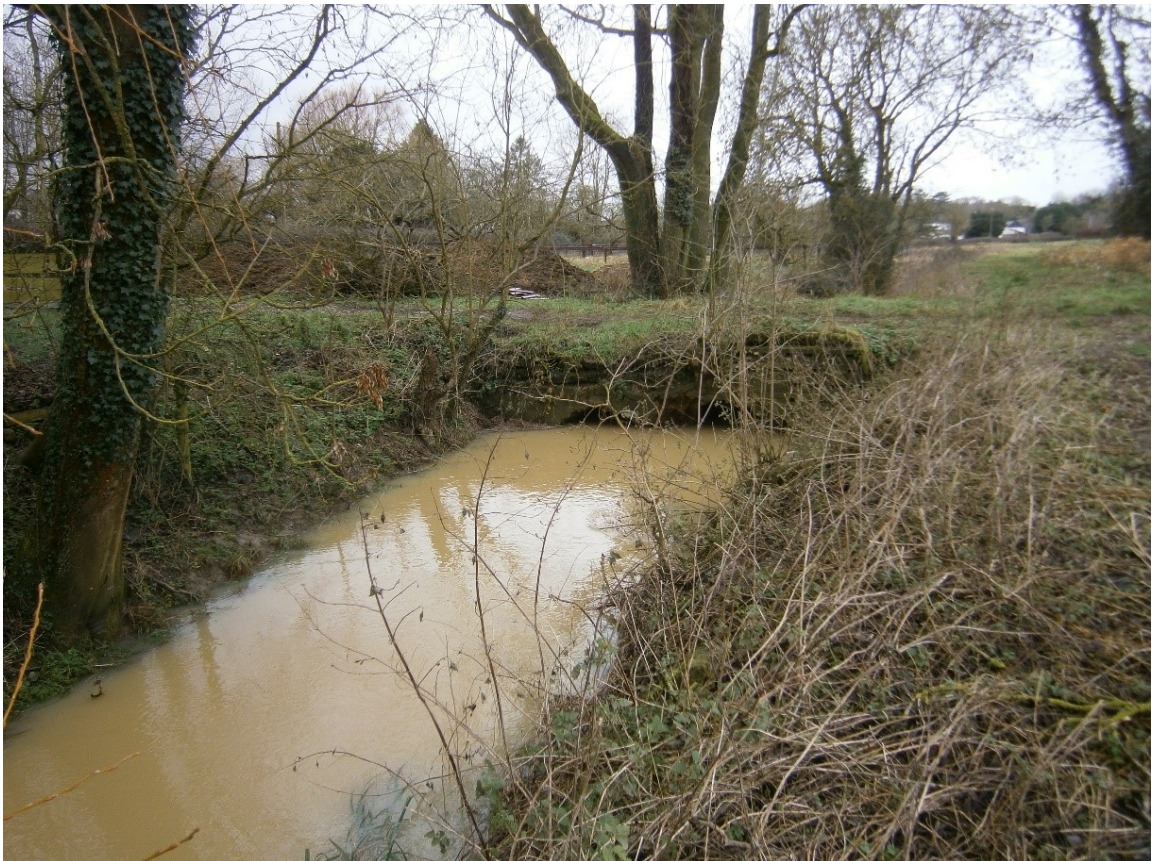
Photographs no. 4a & b. The bridge at College Farm prior to its removal in 2021. The difference in water level between the two sides in surge conditions is similar to that at restriction 2

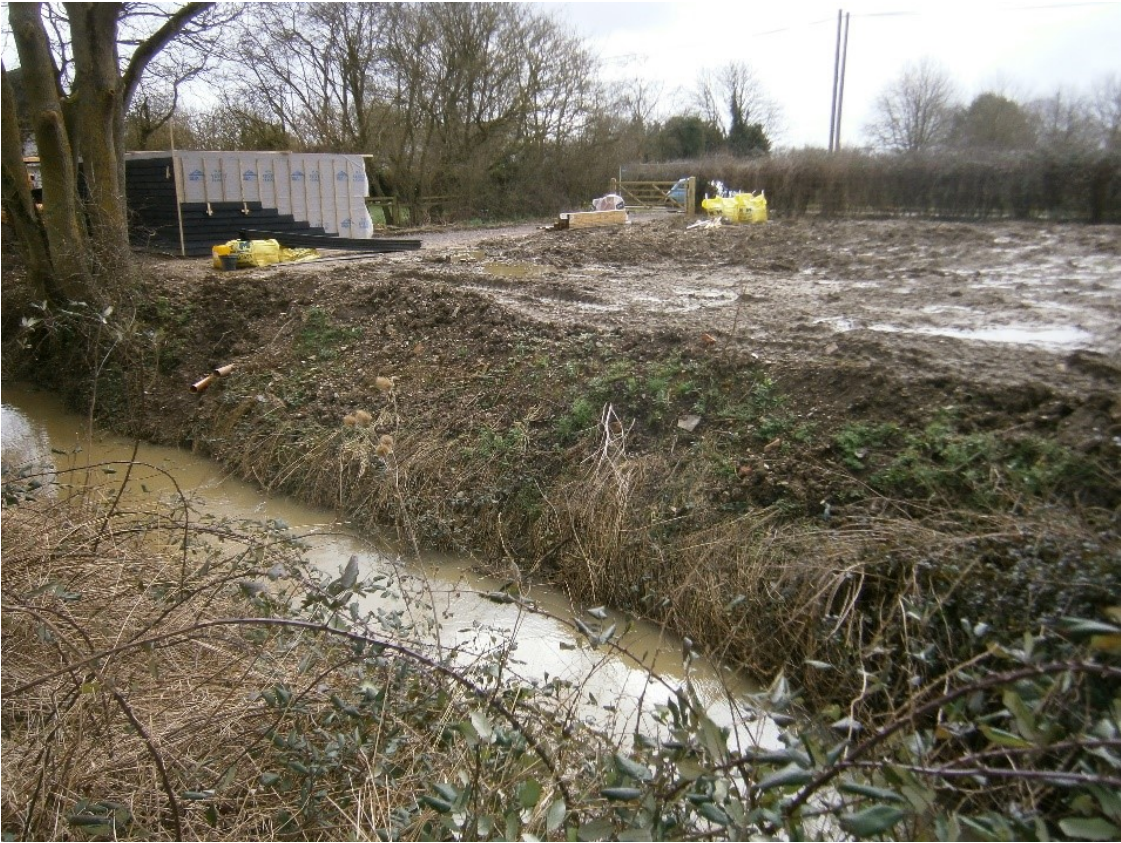
Photograph no. 5 taken of land adjacent College Farm on 21 February 2022. There had been some rain in the preceding days. Note the level of the site compared to the land beyond in photograph no.6 below.

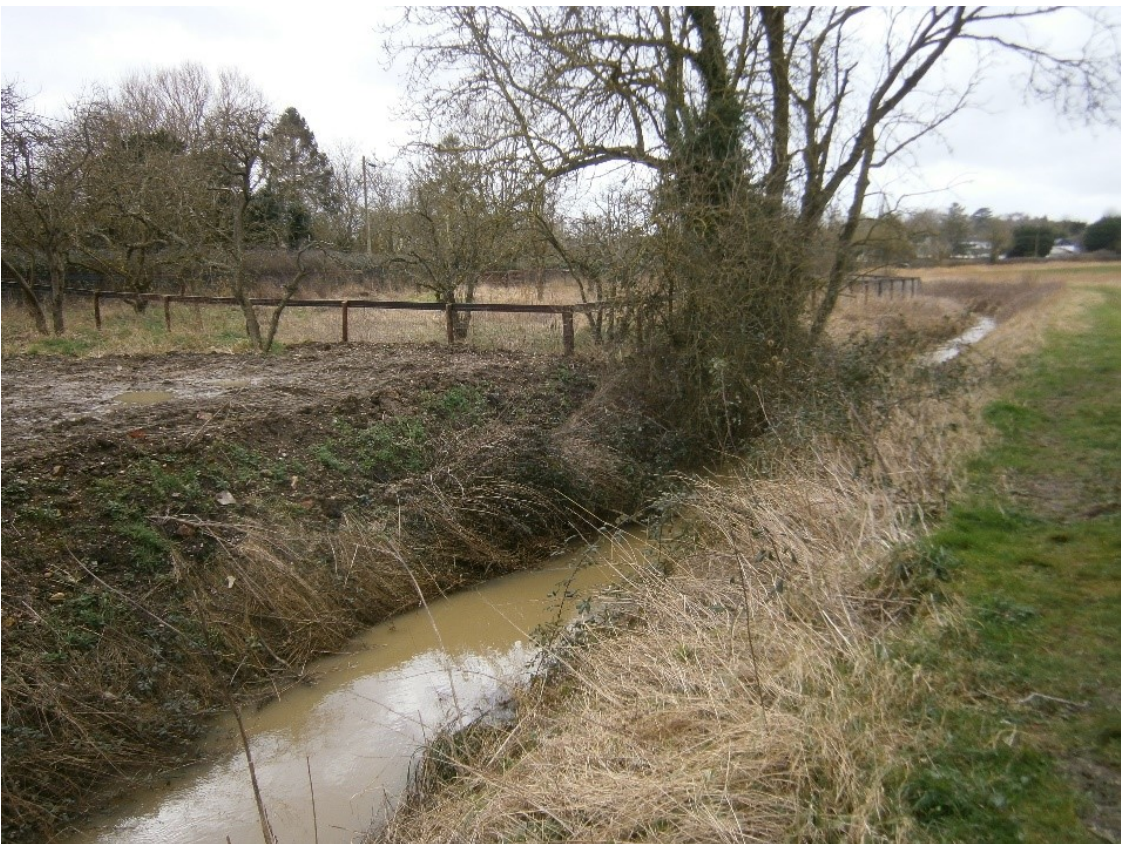
Photograph no. 6 taken of the site and adjacent land on 21 February 2022.

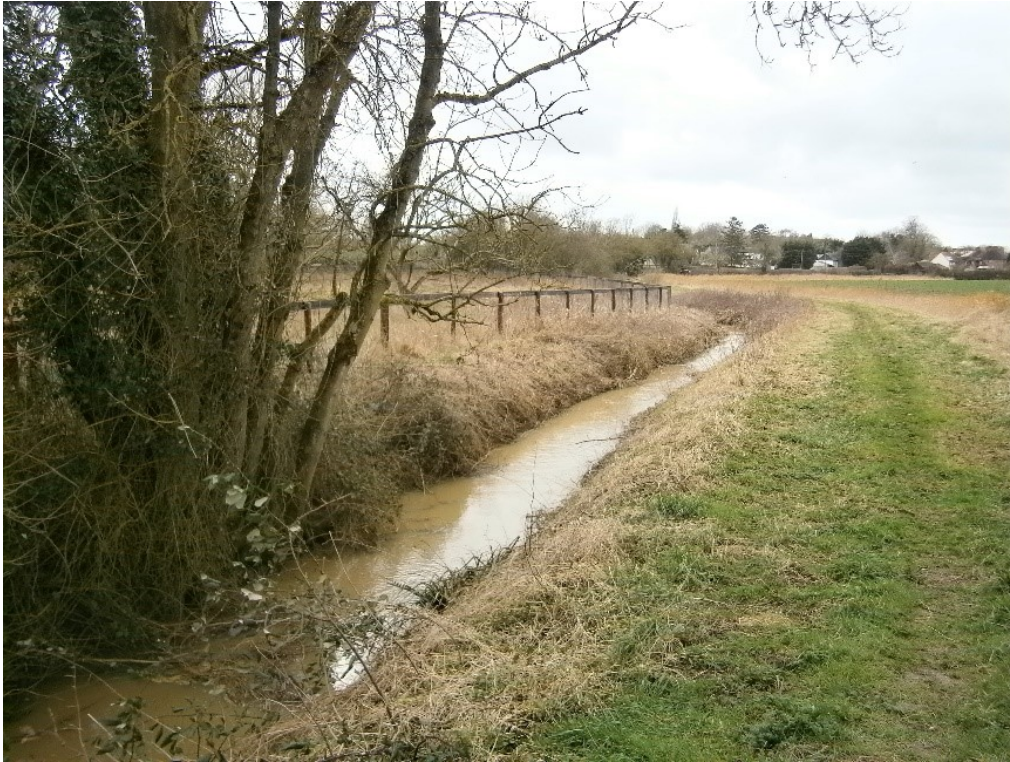
Photograph no. 7 taken of the land adjacent to the site on 21 February 2022. Note the levels of the banks on either side.

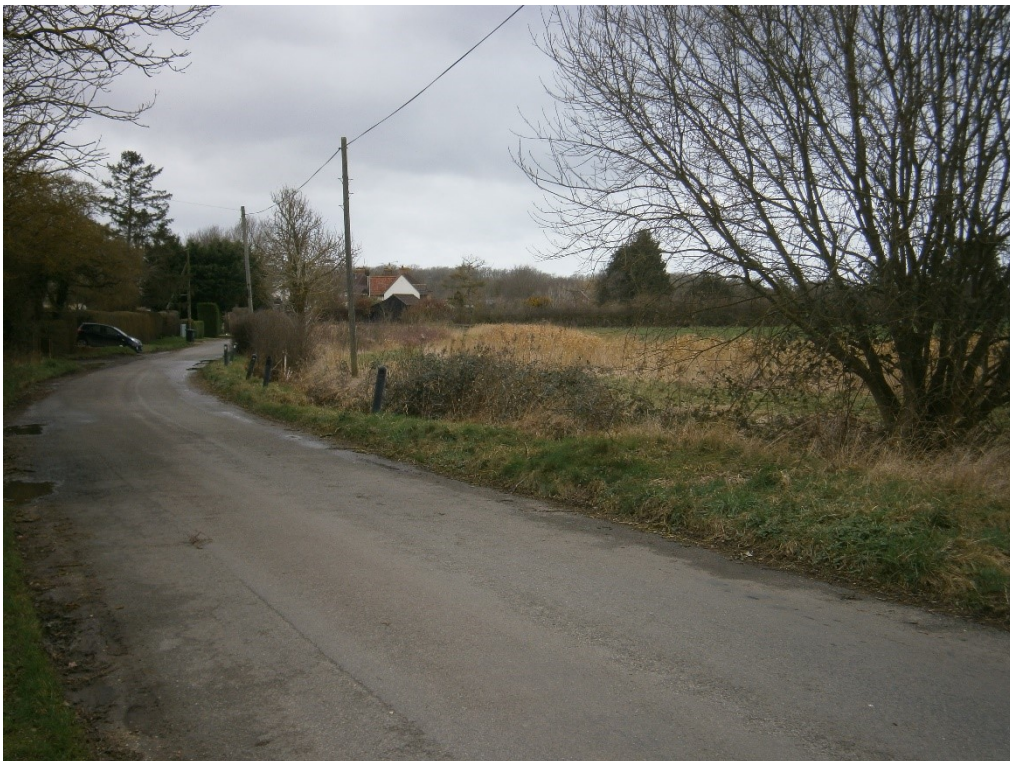
Photograph no. 8 taken of the land from Fox Hall to 63 The Green (White house in distance)

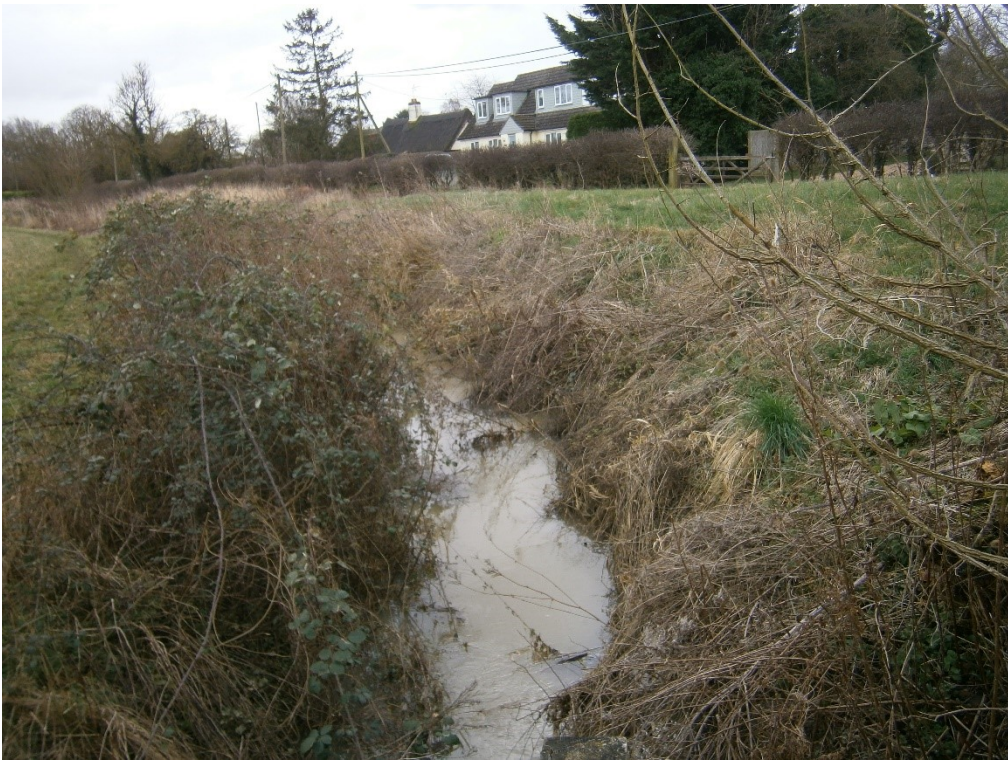
Photograph no. 9. The R.Stour running opposite Stour House on 21 February 2022 (note: the land is now much higher on the right than the other bank).

I recommend that the Parish Council advise the owners of no's.63, 62 and 62a The Green to restore the original bank of the watercourse, clear its bed of silt, and raise any bridges that are currently too low and which will act to restrict the flow of water in a flood event. Only by removing the restriction to flow that these properties currently present can they mitigate the increased risk of flooding identified in this report.

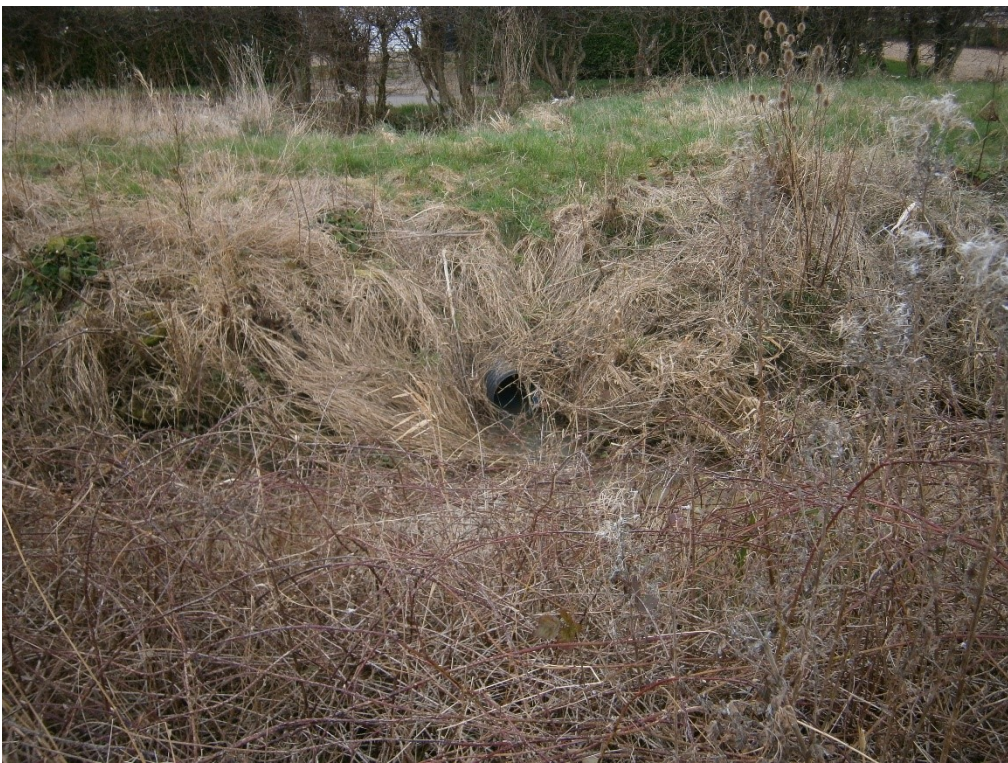
The piping of the ditch referred to above presents a different problem. The ditch that was opposite "Old Orchard" took the water from the road drains and from the ditch running between "Old Orchard" and "Stour House". It is also the path for floodwater to escape when the road is flooded. As it is at the lowest point it acts as the outlet for the new balancing pond formed by the raising of the land opposite Stour House. With the piping of the ditch that outlet is now restricted. Note: It is illegal to pipe a ditch without the authority of (in this case) Cambridgeshire County Council.

Photograph no. 10. The piped ditch on 21 February 2022.

I recommend that the Parish Council remind parishioners that it is a legal requirement to obtain the authority of the County Council before piping ditches. It is also a legal requirement to obtain the authority of the County Council flood risk officer before altering the flow or bank of a watercourse if the effect could be to increase the risk of flooding to other properties.

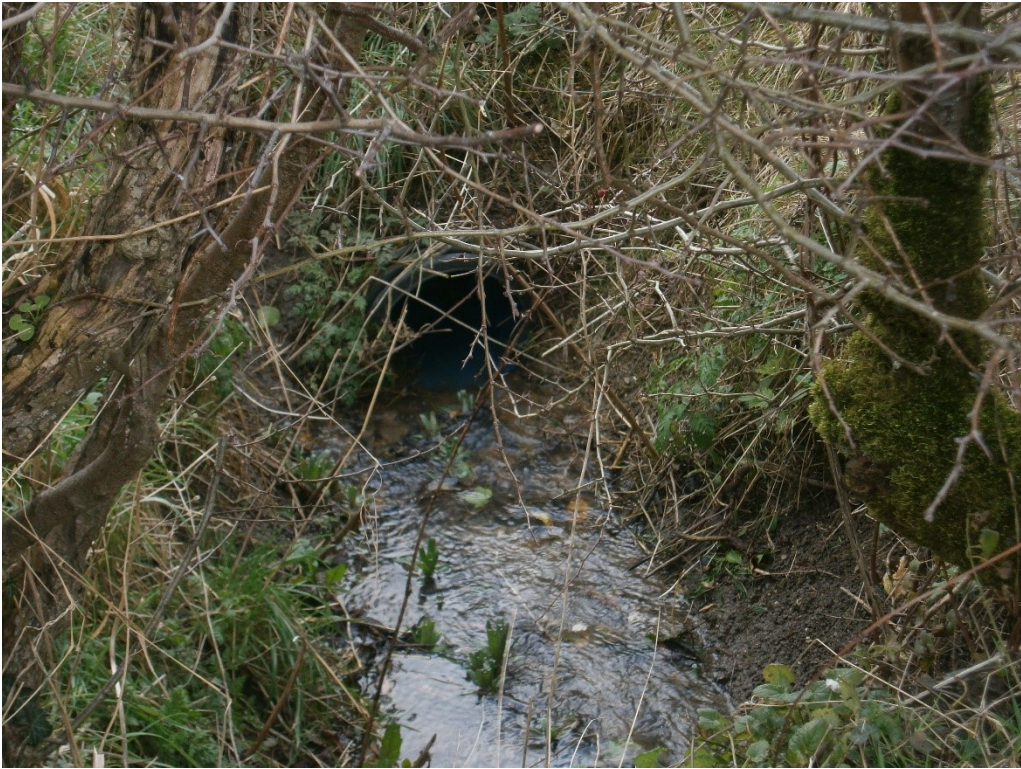
Photograph no. 11. Common Road end of piped ditch opposite “Old Orchard” on 21 February 2022.

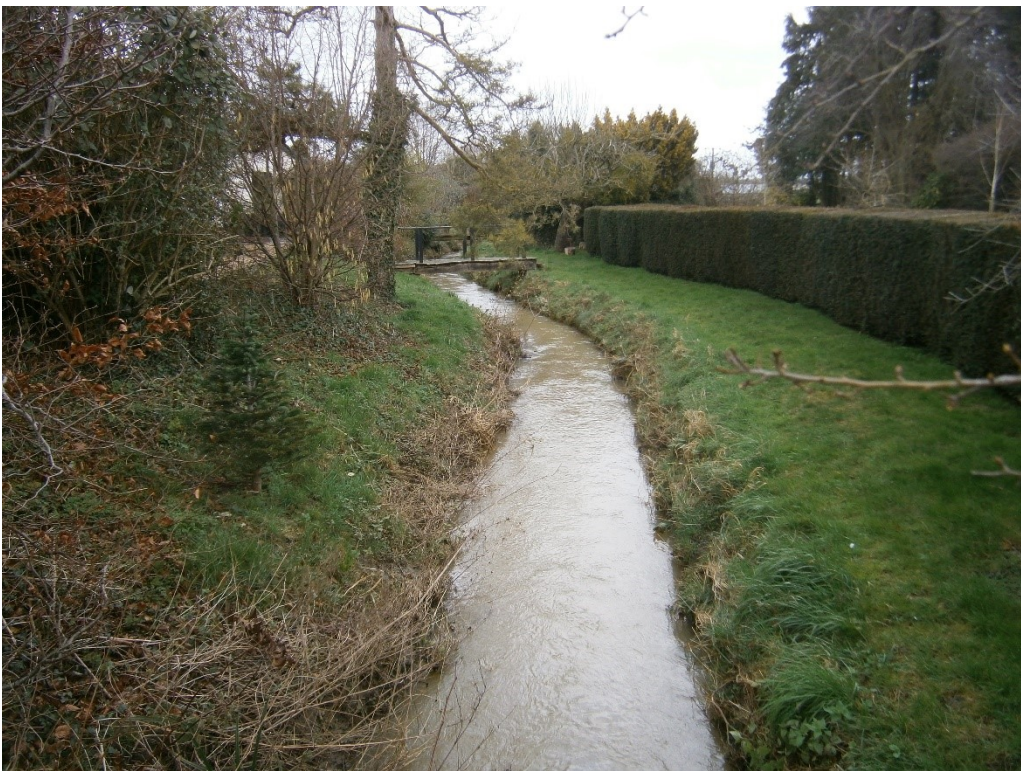
Photograph no. 12. The R.Stour running through 63 The Green on 21 February 2022. On 25 June 2016 the water was above the bank on the left.

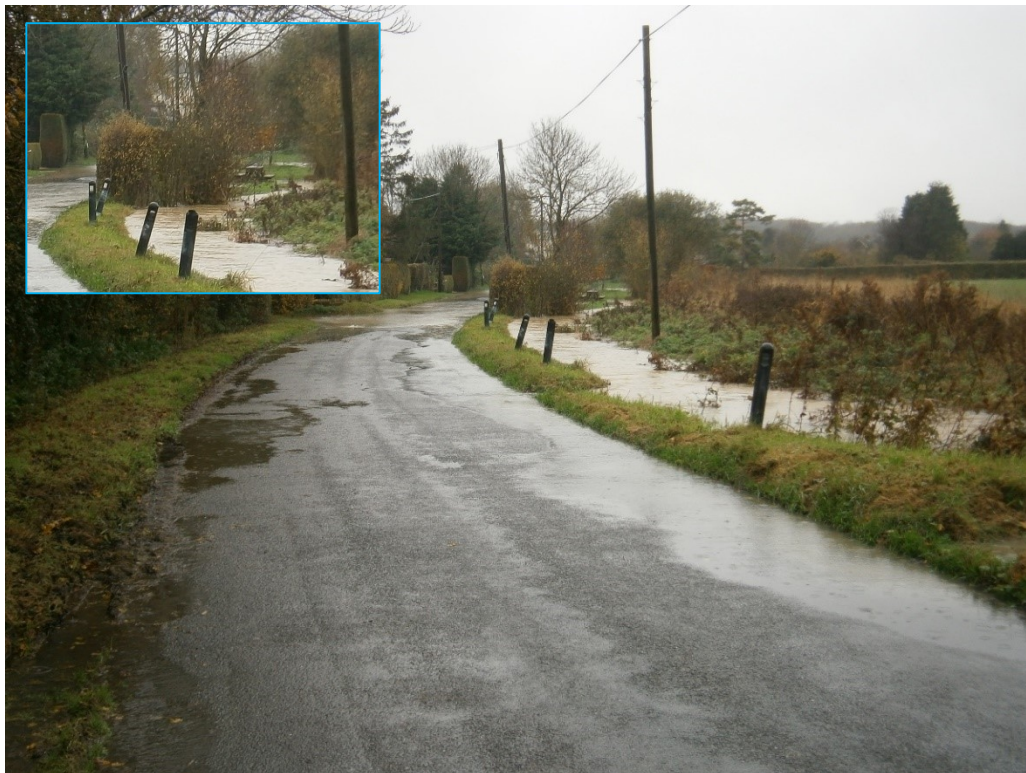
Photograph no. 13 taken of Common Road 135m north-west of the site on 23 November 2014. This has happened several times in the last 20 years.

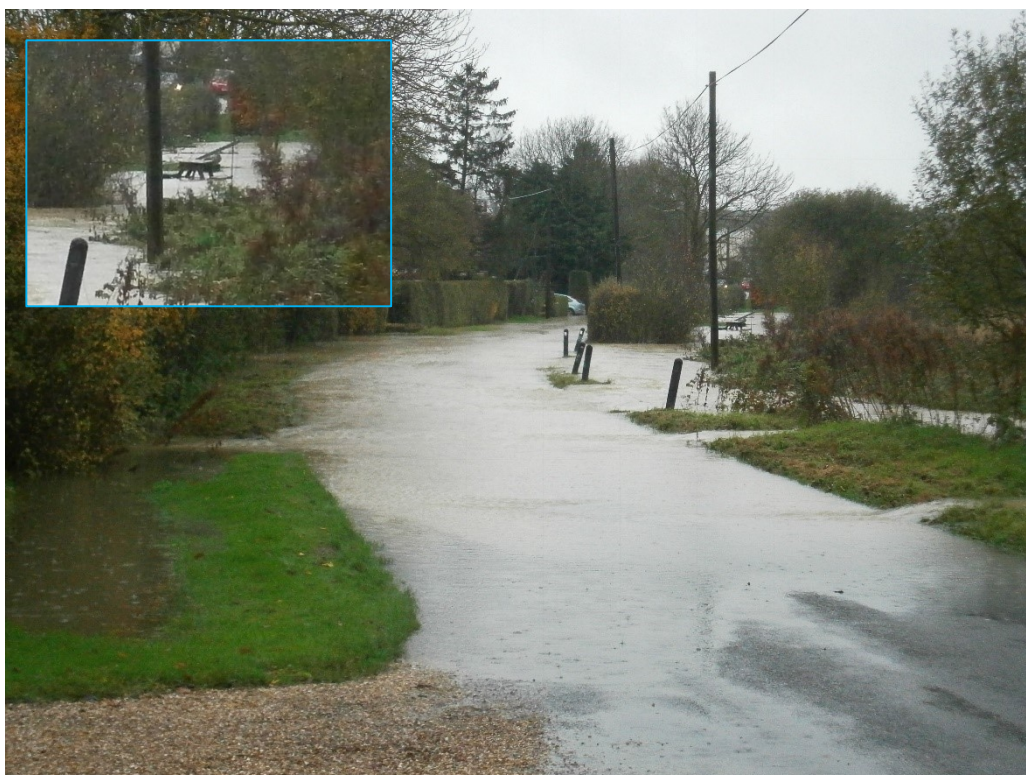
Photograph no.14 taken of Common Road two hours later than photograph 14. Note the picnic table sitting in the water. This land has subsequently been raised. This photograph emphasises the importance of both this and the land adjacent College Farm as flood plain.

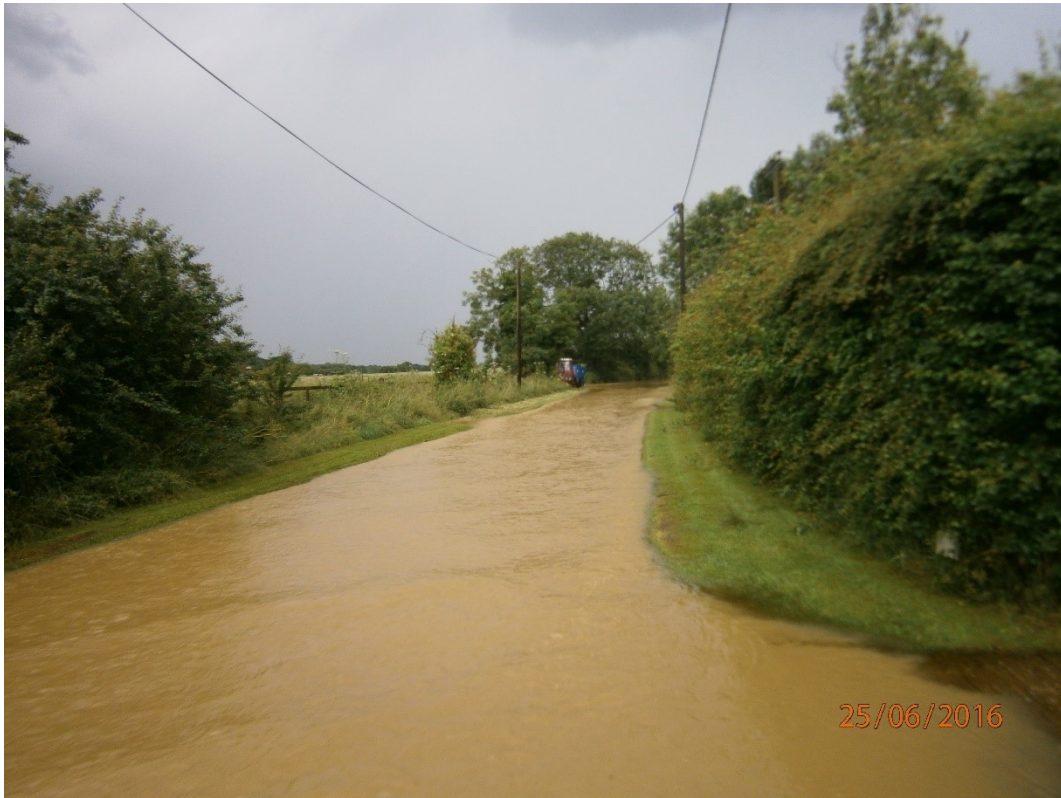
Photograph no. 15 taken of Common Road adjacent College Farm on 25 June 2016.

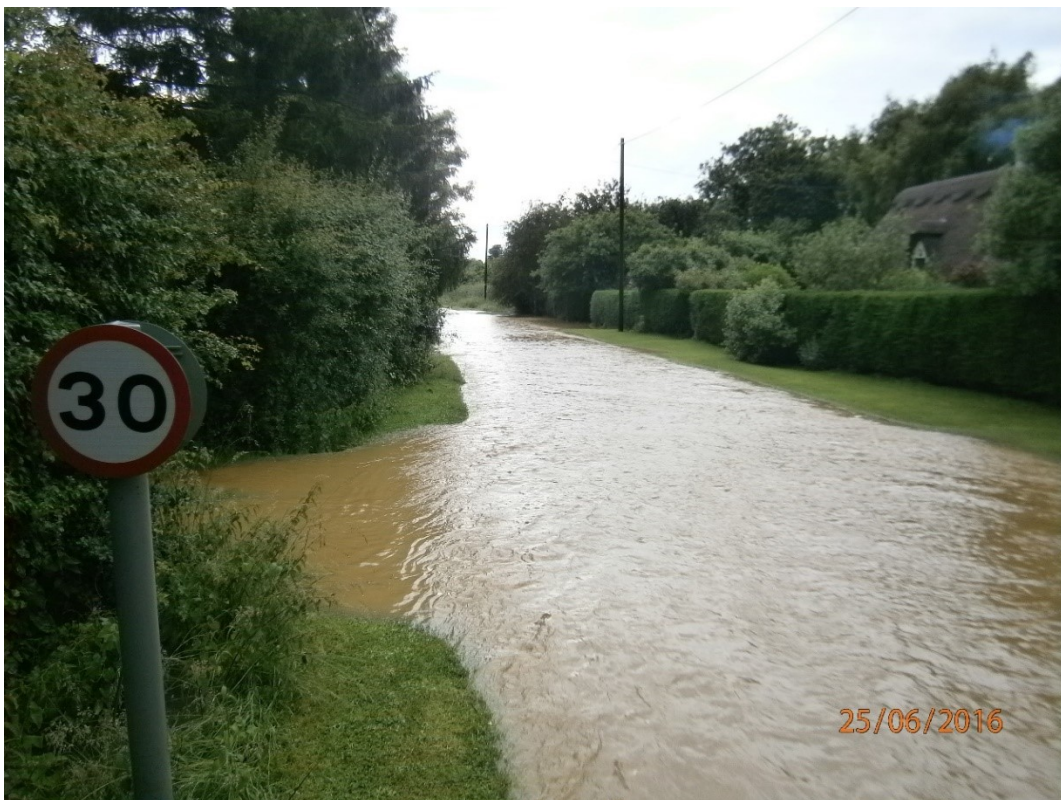
Photograph no. 16 taken of Common Road outside College Farm on 25 June 2016. Part of College Farm (grade 2 listed building was flooded).
